# LHDにおけるタングステン研究の進展

核融合科学研究所

時 谷 政 行

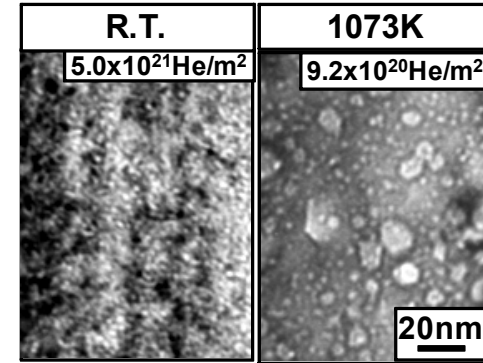
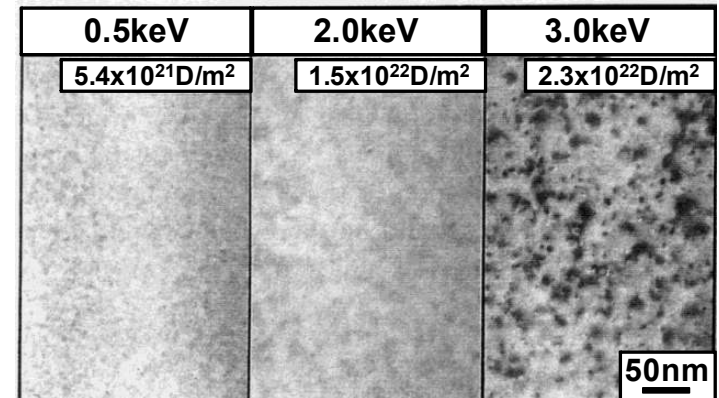
TEM images of W irradiated with (a) 0.25keV-He<sup>+</sup> in different temperature and (b) various energy of D<sup>+</sup> in room temperature.

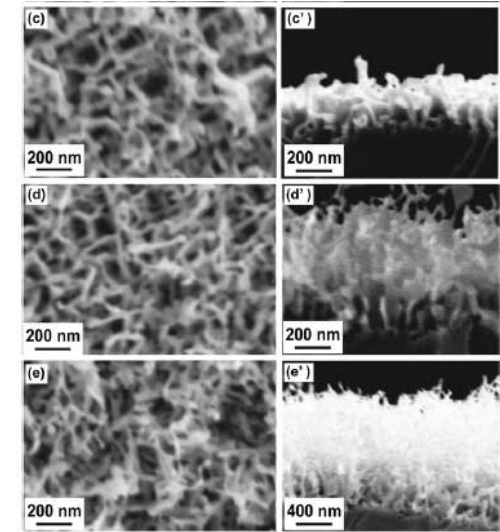
Fig. 1. Growth process of W-fuzz irradiated with low energy He ion (up to  $5.5 \times 10^{25} \text{He/m}^2$ ) [1].

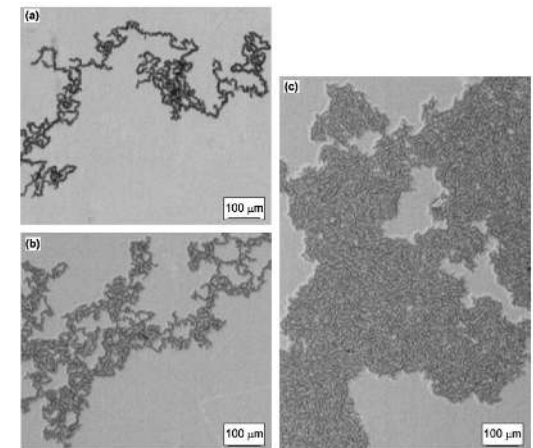
Fig. 2. Picture of the arc trails on W-fuzz specimen in NAGDIS [2].

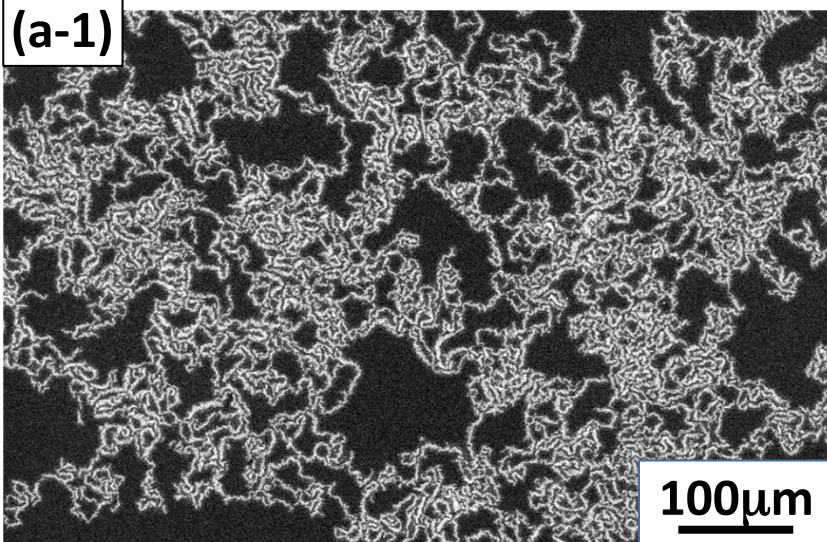
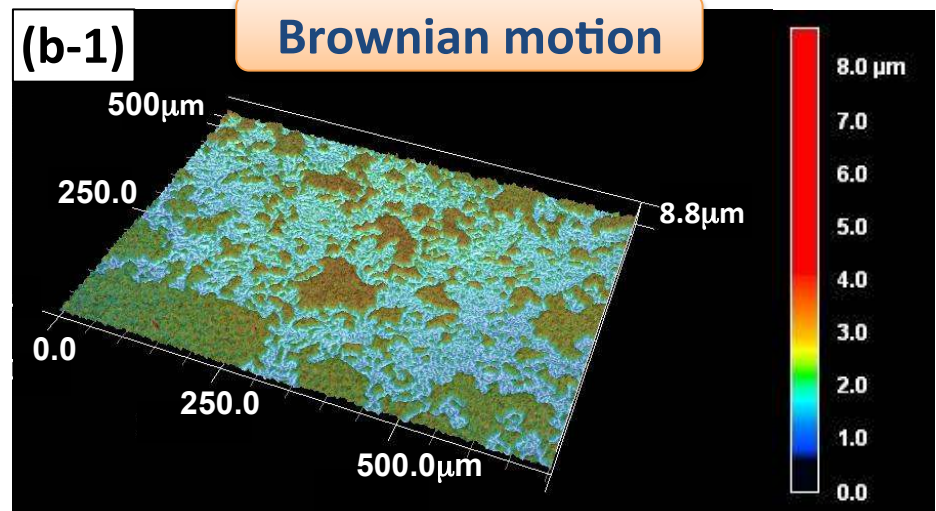
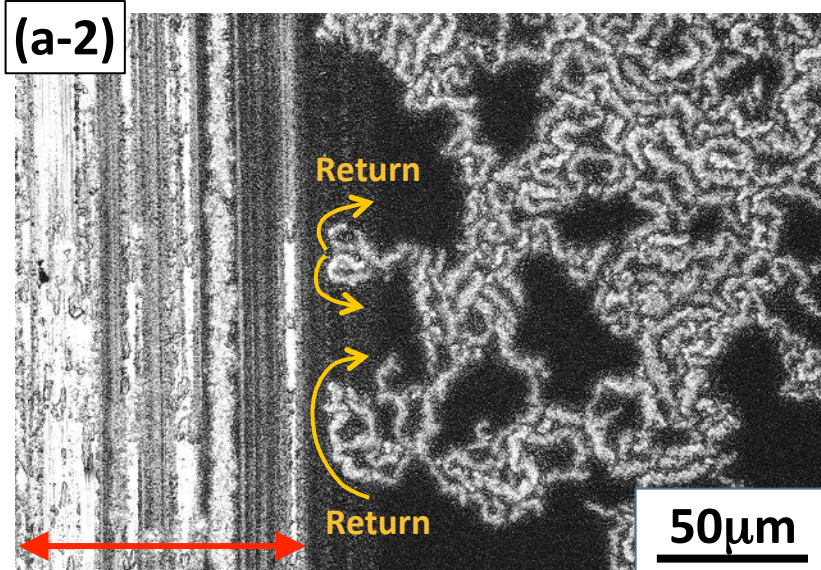
- ◆ Very fine and randomly moved unipolar arc trails were clearly observed. Spot size : 8μm (W) x 1μm (D).
- ◆ The fuzzy surface was exfoliated by continuously moving arc spots even for the very short exposure time (< 2s).
- ◆ This is the first observation of unipolar arcing and exfoliation of some areas of the W-fuzz structure itself in a large plasma confinement device with high-magnetic field.
- ◆ Their motion was almost equal to Brownian motion (Fractal analysis).
- ◆ Arc spots cannot go inside of the scratched line.

W-fuzz can lead to the initiation of arcing and subsequently cause a large scale exfoliation of W and provision of a significant W source.

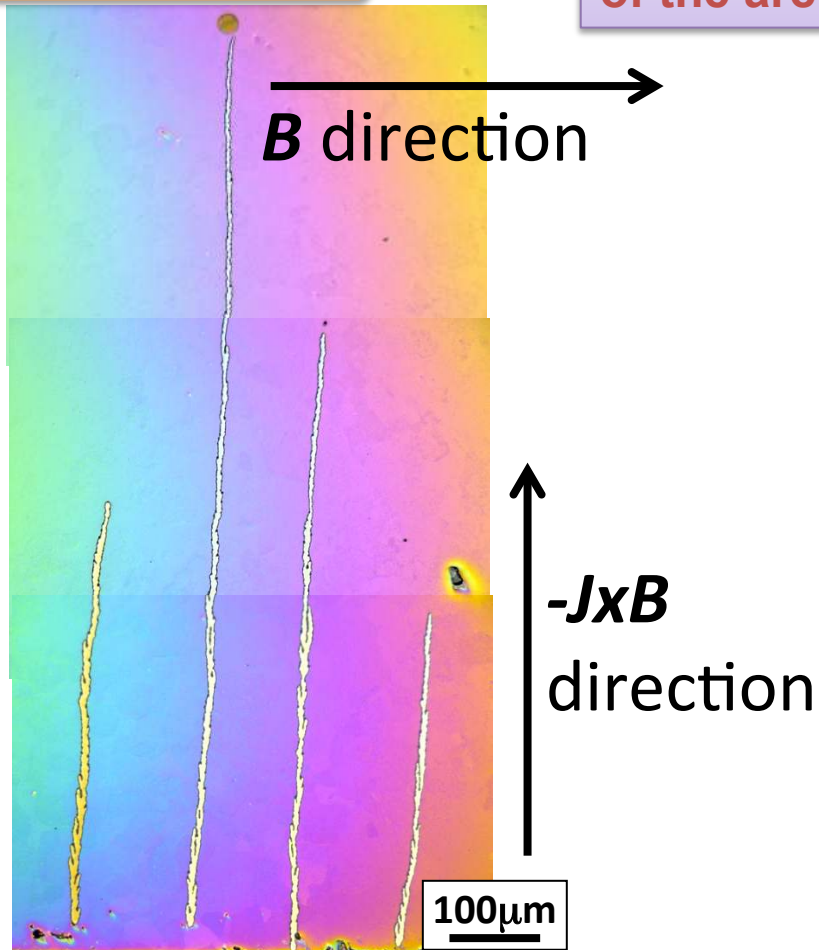
Linear motion

Direction of the magnetic field line is important for the motion of the arc spots.

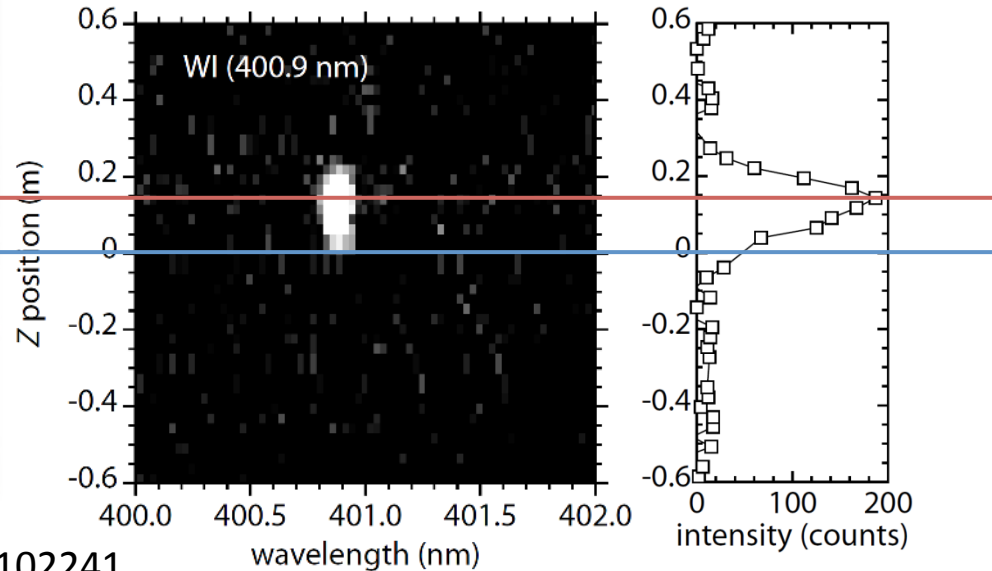
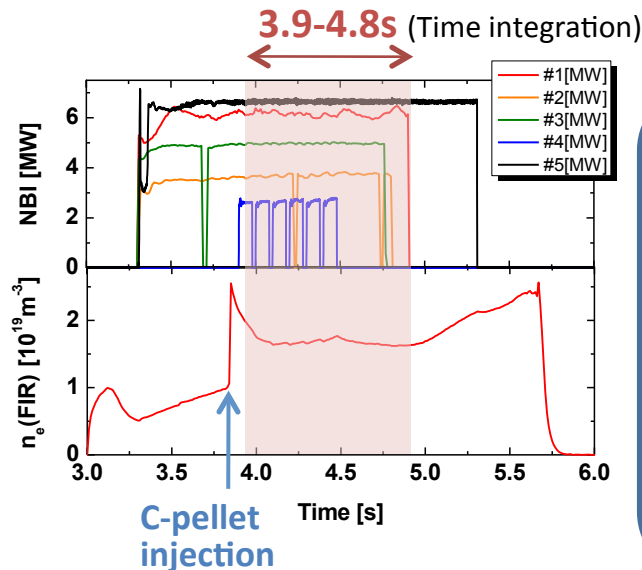
#102241

- ◆ Emission of WI line was clearly observed from the W-tile by visible spectrometer with the integration time between 3.9-4.8s.
- ◆ Spatial distribution of the WI emission does not show broader. This means that emitted W atoms not so deeply injected into the bulk plasma.
- ◆ Starting time of the WI emission seems to be close to the timing of the C pellet injection.
- ◆ Relationship of the C pellet injection and WI emission should be considered in subsequent analysis.

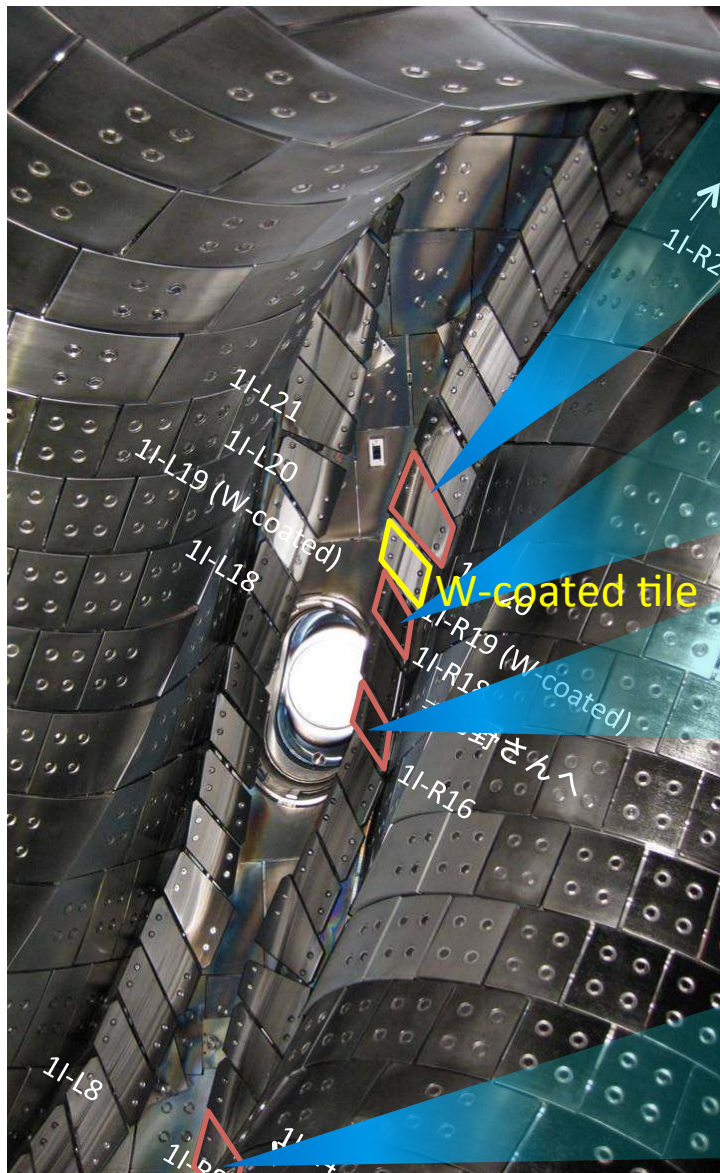
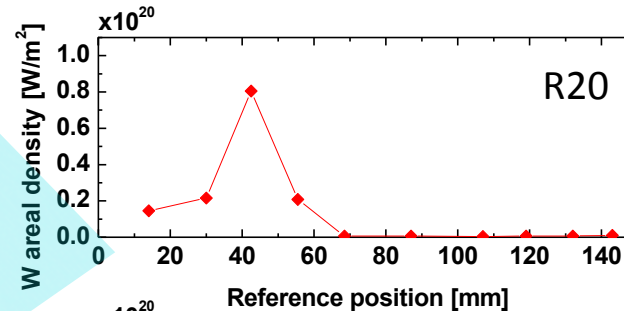
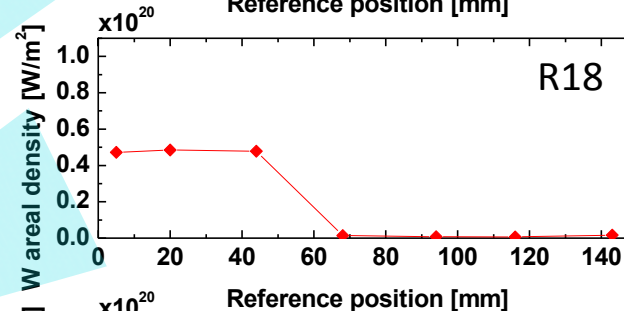
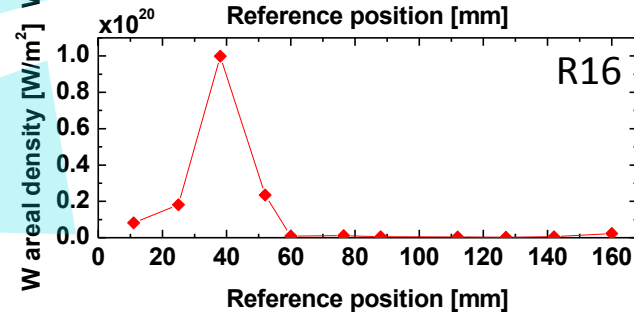
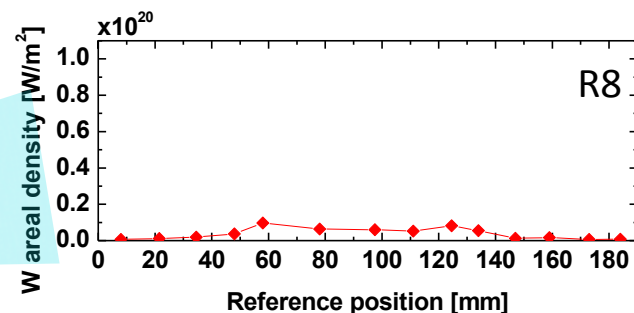
- ◆ Distribution distance of the sputtered W atoms were not so far.
- ◆ Deposited W atoms were mostly located on the private region.

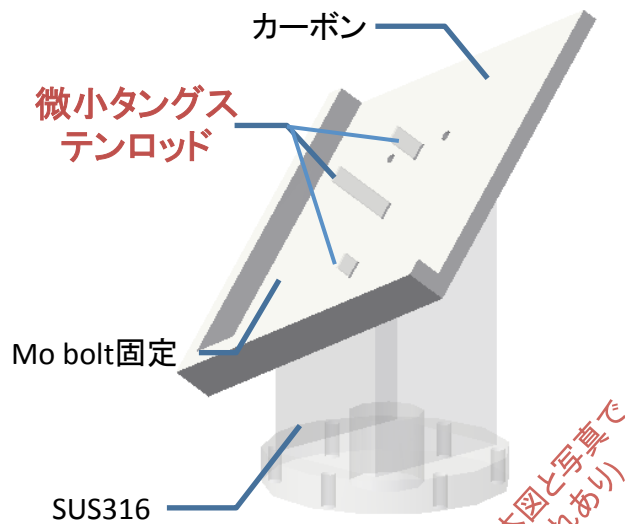
照射後のタングステンロッドの写真

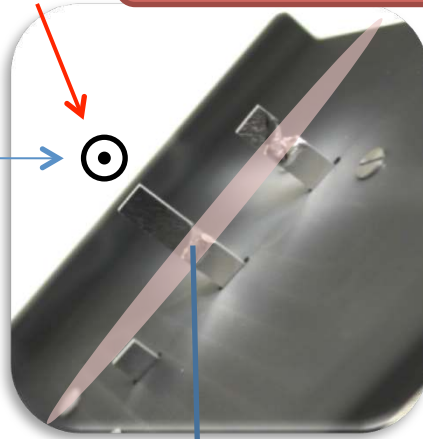
プラズマとWロッドの接触の当初の予想ポイント

ダイバータプラズマの磁力線は本図と写真では紙面にほぼ垂直方向(多少のずれあり)

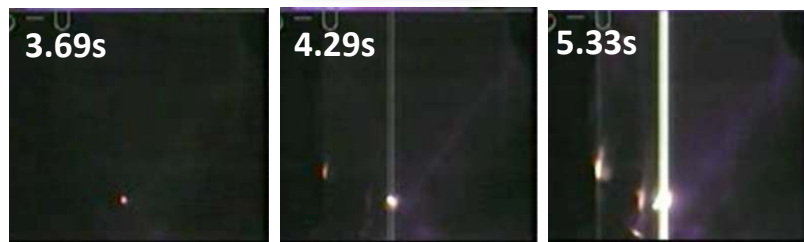
タングステンロッド発光の時間変化 (#103256)

- ◆ 溶融が確認される2本のタングステンロッドにダイバータプラズマが照射された。黒鉛タイルとは接触していない。
- ◆ 放電時間の経過と共にロッド先端部の発光が顕著になる。
- ◆ W溶融物の飛散をカメラで確認することはできなかった。
- ◆ 可視分光計測より、タングステンロッド周辺部にWIラインスペクトルの強い発光が確認された。
- ◆ バルクプラズマ中での発光は見られなかったため、プラズマへの目立った影響はなかった。
- ◆ 黒鉛タイルに飛散したタングステンの付着が確認されたため、今後分析を行い、タングステン元素放出の方向依存性を導出する予定。

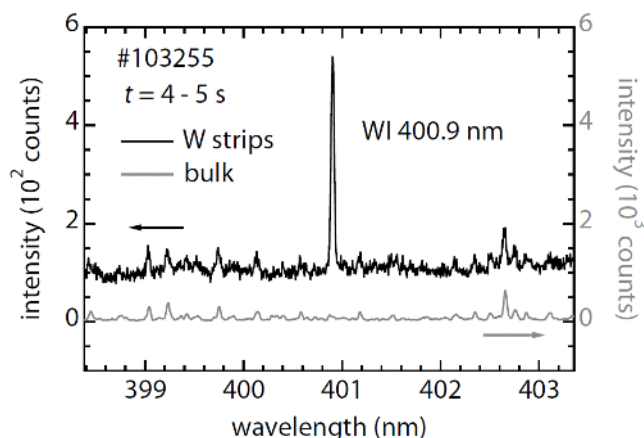
タングステンロッド周辺部とバルクプラズマ中でのWI(400.9nm)スペクトルの比較(#103255)

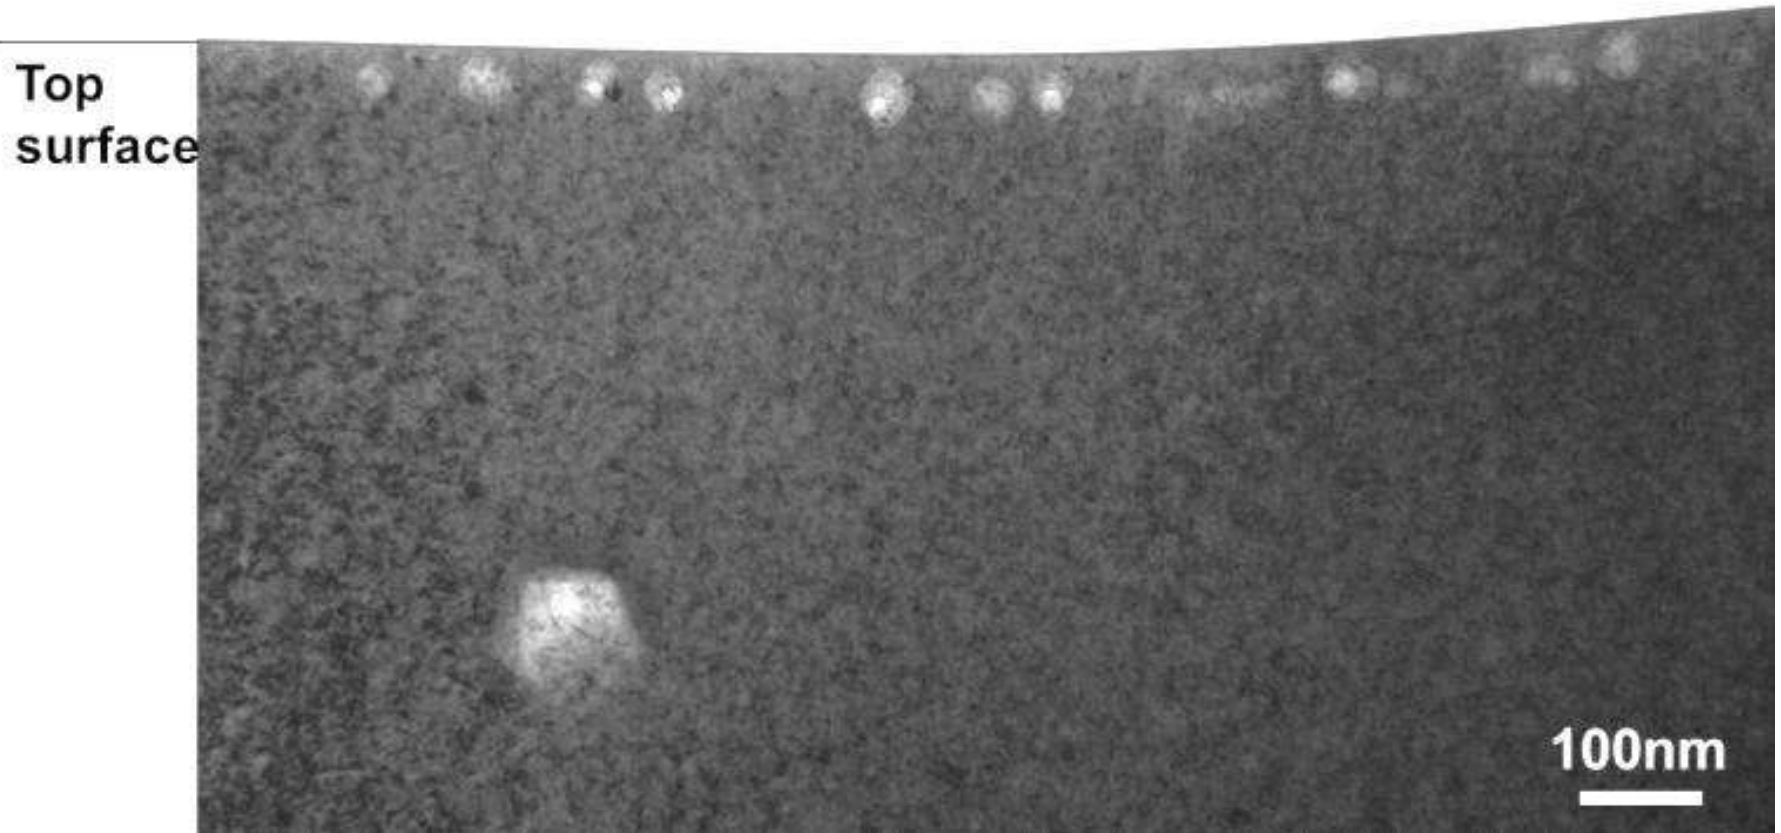
TEM images of W irradiated with LHD divertor plasmas.  
100-200eV,  $\sim 10^{22-23}$  ions/m<sup>2</sup>s.

- Unexpected damages such as formation of fine cavities were observed in the LHD experiments
- Synergistic effects of high-heat and -particle loads would cause the undesired extensive damages for tungsten, and such damages change the retention property of the hydrogen isotope.

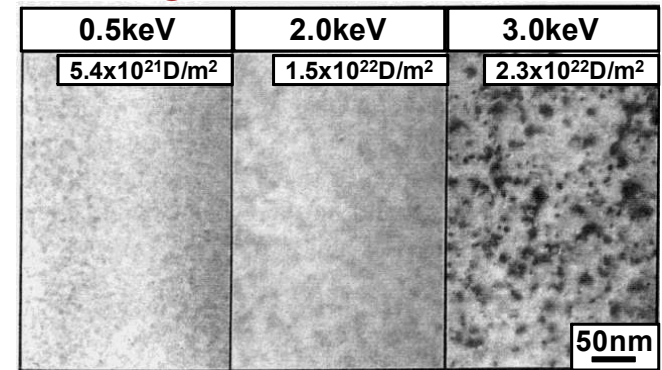
TEM images of W irradiated with various energy of D<sup>+</sup> in room temperature.

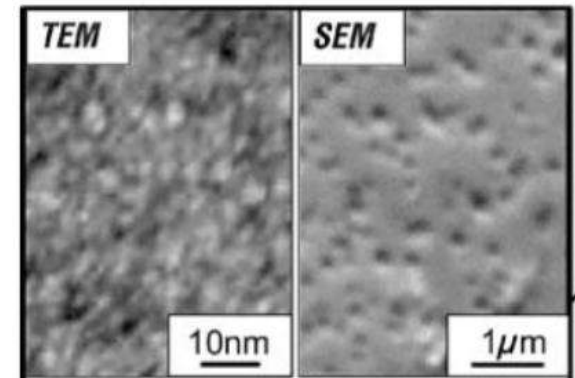
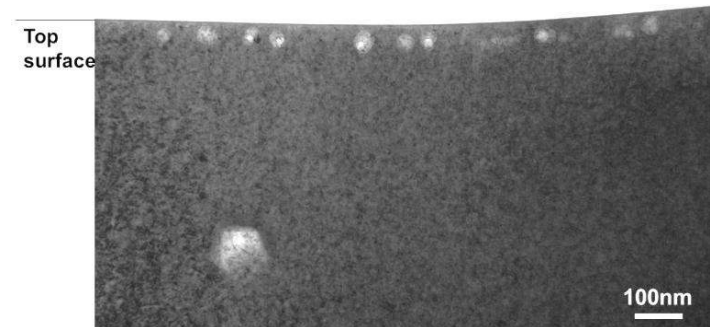
TEM images of W irradiated with LHD divertor plasmas. 100-200eV,  $\sim 10^{22-23}$  ions/m<sup>2</sup>s.

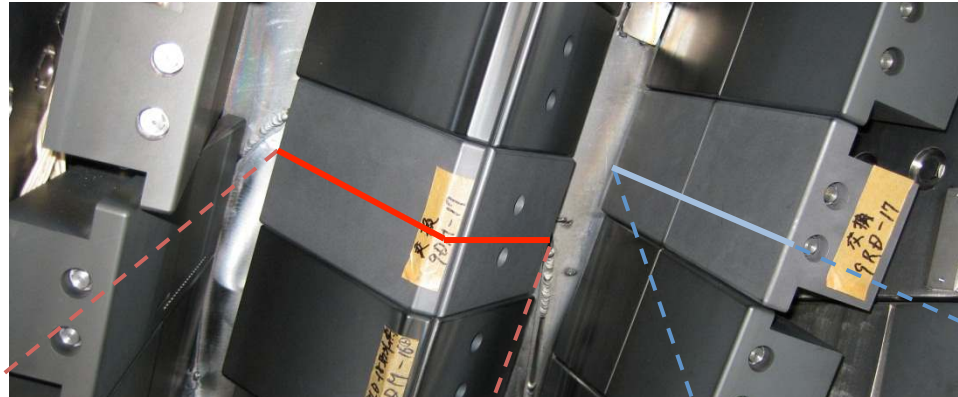
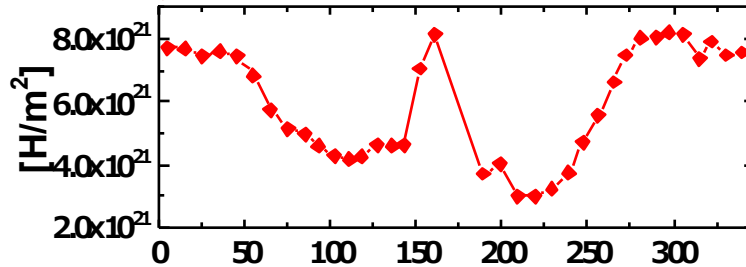
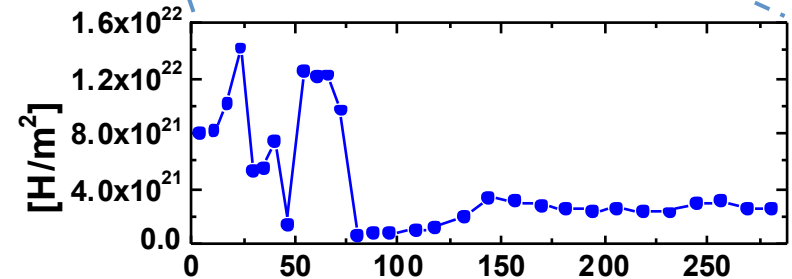
High H retention was located at the Lower and top region.

Highest H retention  $\sim 1.5 \times 10^{22} H/m^2$  was observed near the strike point. The value was about two times higher than that of the open divertor tile.

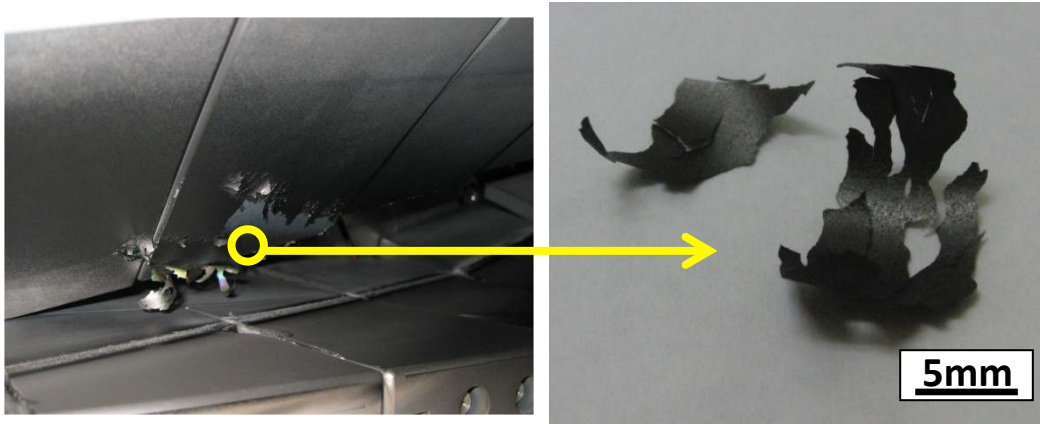
Firstly, Fe impurities were deposited, and then, majority of the impurity element was changed to the C at the late stage.

*Fe deposition layer act as the initiator of the exfoliation of the whole deposition layer! [1]*

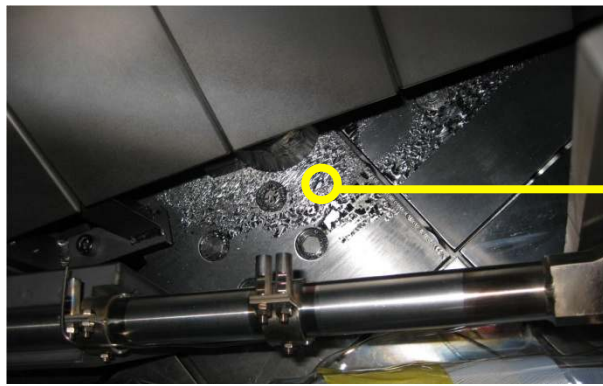
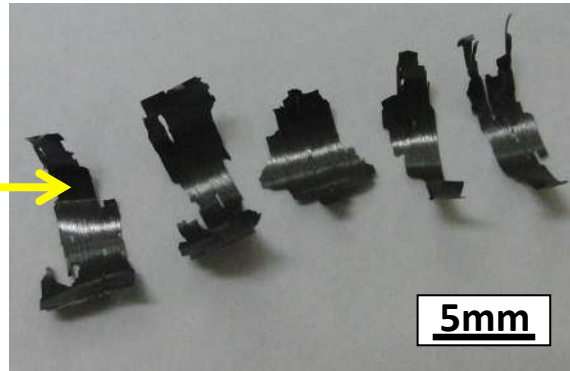
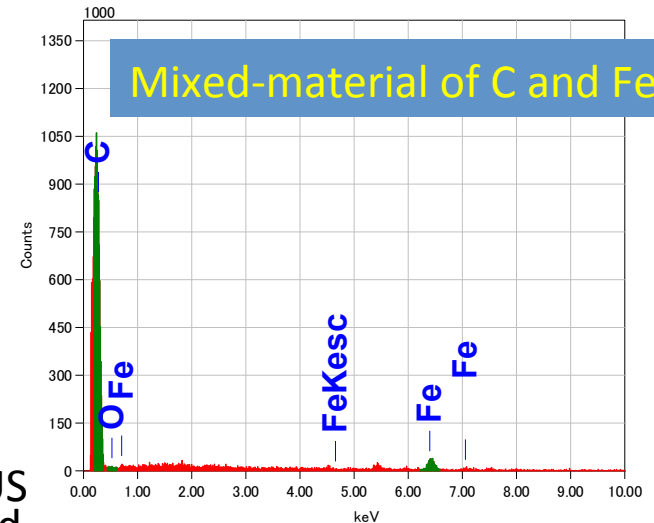
Fine scratched like structures were formed.

Such scratched structures would have been caused by the SUS substrate. Because SUS wall surface has the original scratched structures due to the mechanical polish.

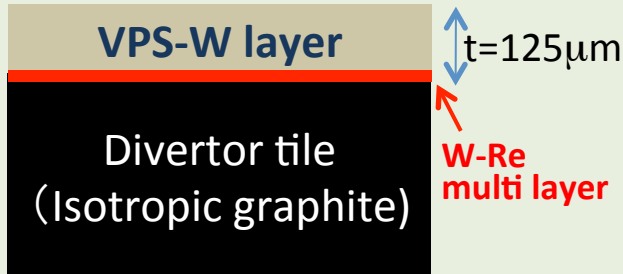
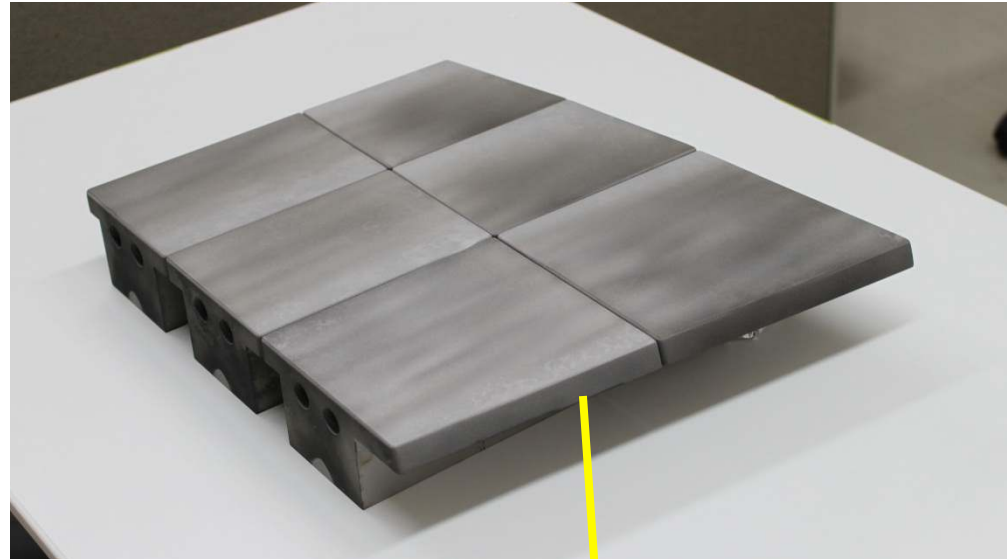
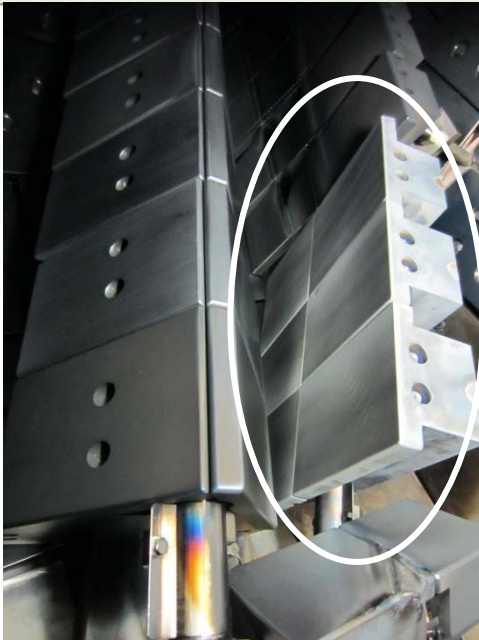
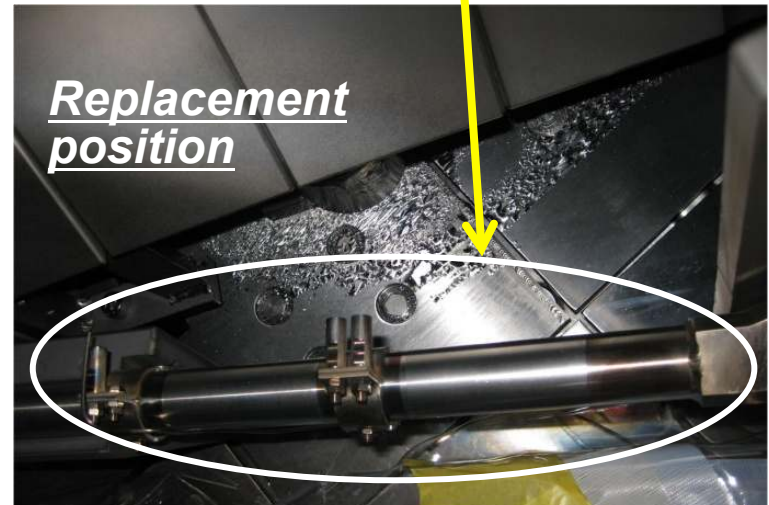
VPS-W coating will be prepared for 3 pairs of divertor tile.  
H inventory and dust generation would be suppressed by VPS-W.

The VPS-W layer with 125 $\mu$ m thickness will be coated on the IG tile.

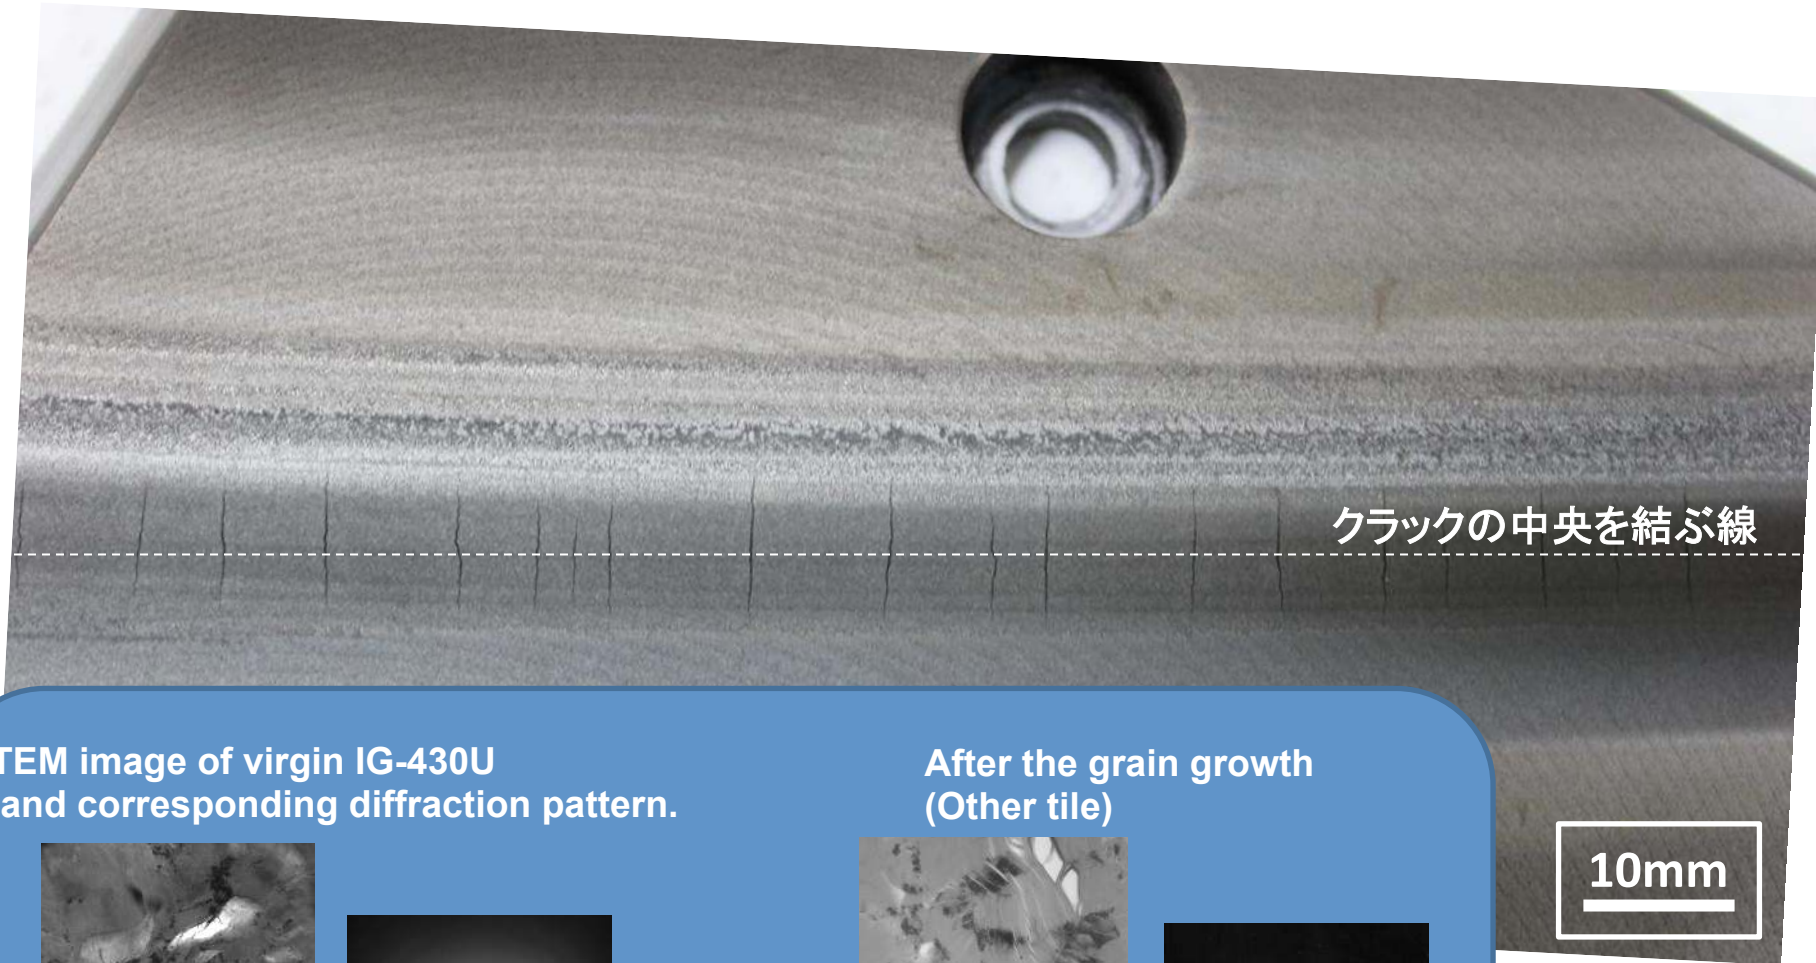
TEM image of virgin IG-430U  
and corresponding diffraction pattern.
